CONNECTICUT DEPARTMENT OF TRANSPORTATION

STATE AND FEDERAL BRIDGE PROGRAM
PRELIMINARY APPLICATION

WEST MAIN STREET OVER
HOCKANUM RIVER

Connecticut Department of Transportation Bridge No. 04573

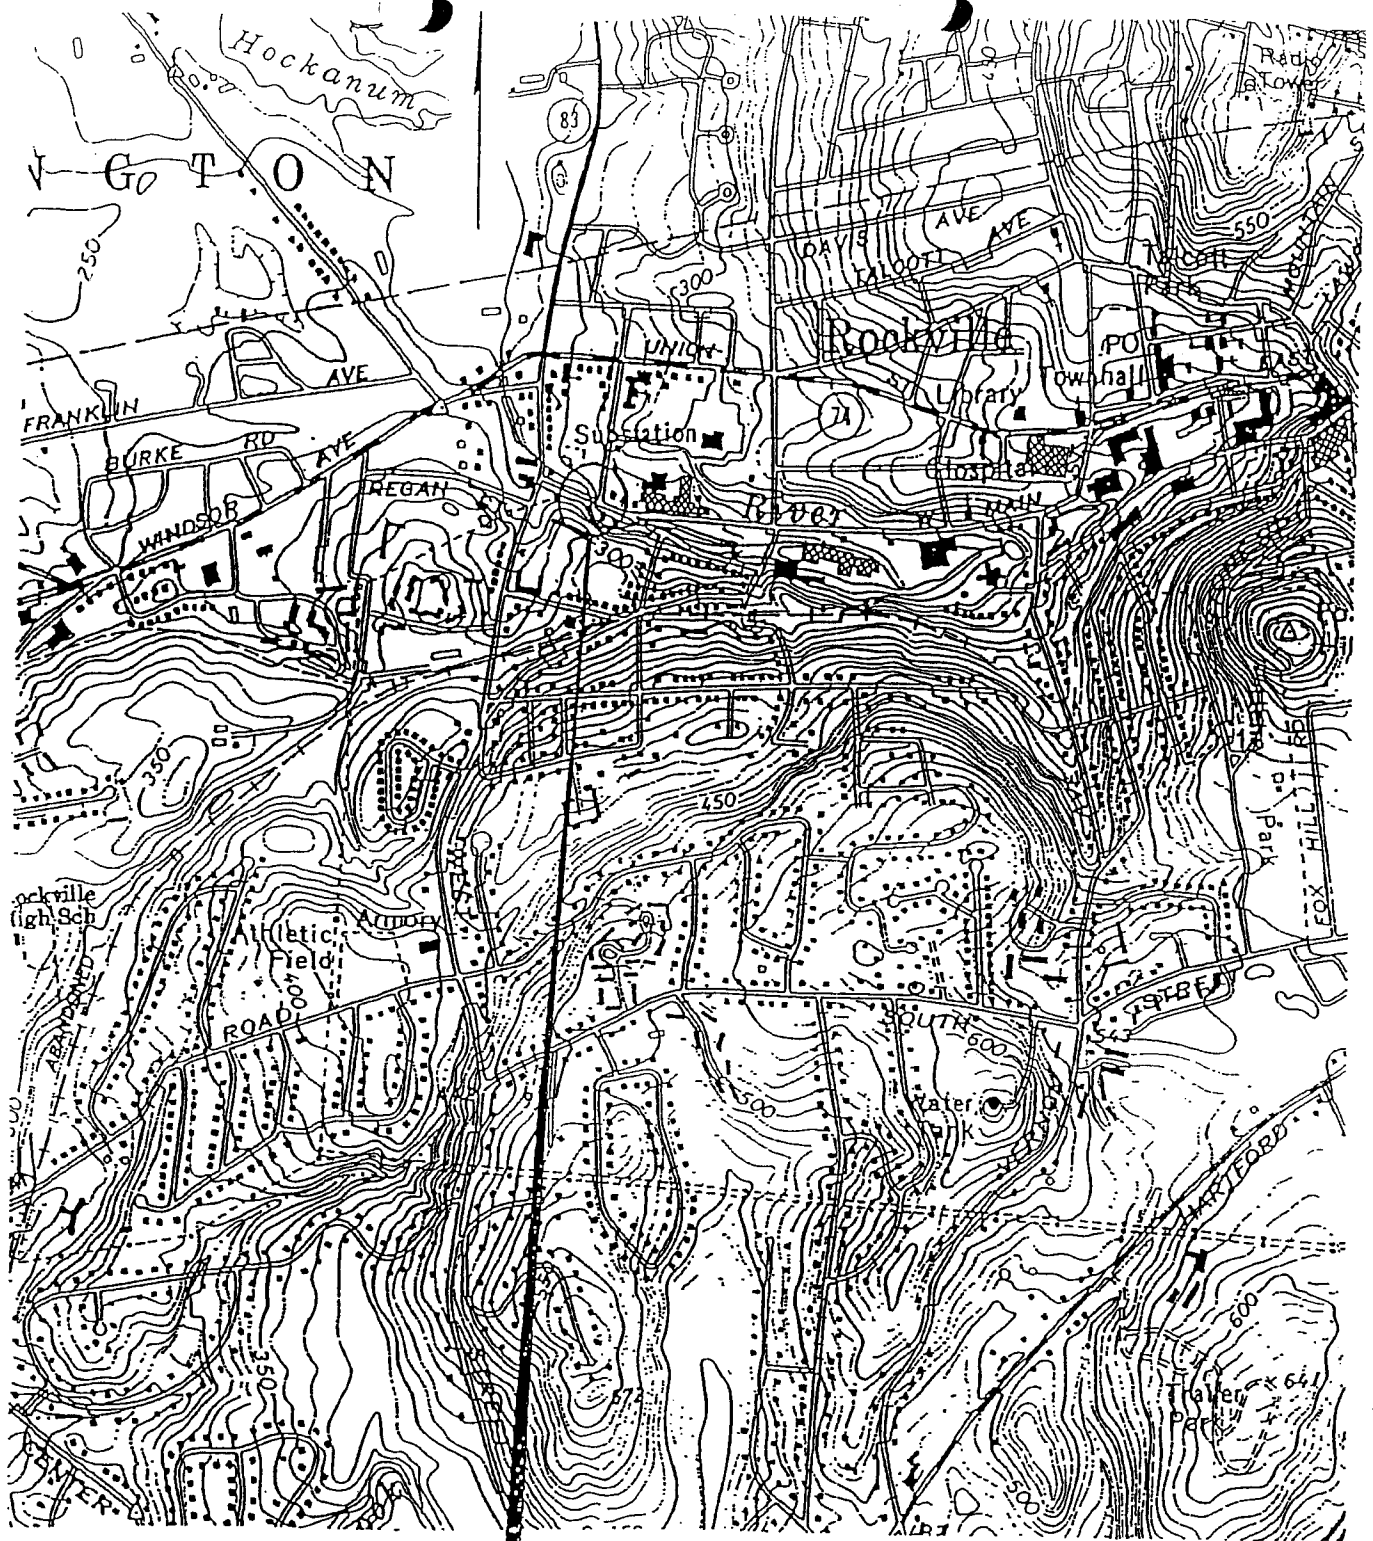
TOWN OF VERNON
PROJECT LOCATION PLAN
WEST MAIN STREET OVER HOCKANUM RIVER
WEST MAIN STREET VERNON

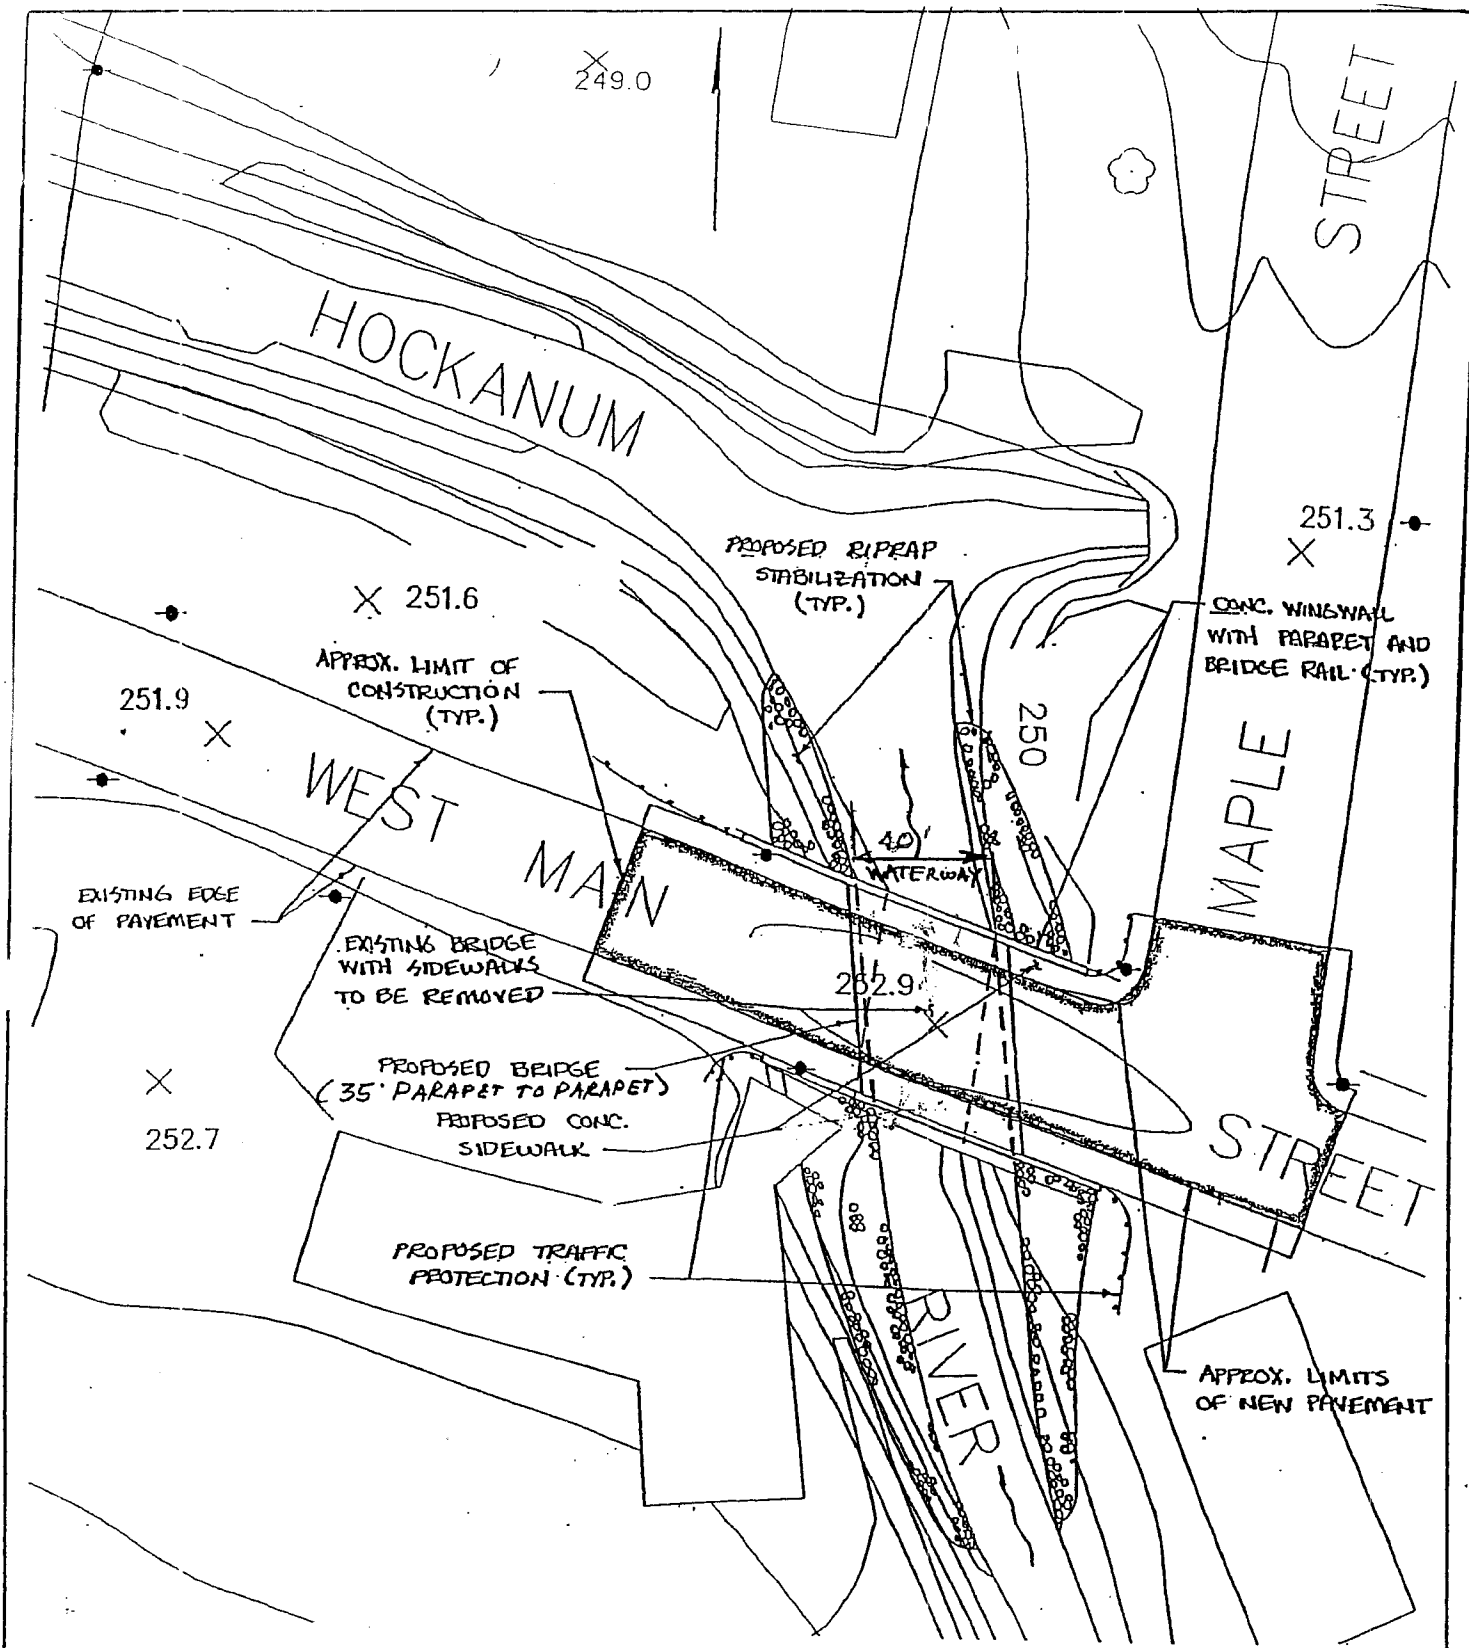
TOWN OF VERNON
SITE PLAN
WEST MAIN STREET OVER HOCKANUM RIVER
WEST MAIN STREET VERNON

The proposed improvements for the West Main Street Bridge consist of removing and replacing the existing structure. The Flood Insurance study shows that the bridge is in flood hazard area AE (base flood elevations determined) and there is a designated floodway in this area. Preliminary hydraulic computations indicate that, in order to comply with the Flood Management Certification requirements, the new structure should have a hydraulic opening of 40 feet. Some of the ConnDOT design criteria for a Large Structure cannot be met within the constraints of the location, street geometry and existing right-of-way. The proposed bridge will be designed to pass the 100-year flow for unencroached conditions, but the freeboard will be less than one foot and the required 2-foot underclearance will not be available. West Main Street is a local street with low traffic volumes and alternate routes are available, therefore according to the Local Bridge Program Manual for Fiscal Year 2008 and the 2000 ConnDOT Drainage Manual, Chapter 9 - Bridges, lower design criteria can be approved by the Department.

proposed to be founded on piles. A 5-foot wide sidewalk is proposed to be constructed along the north side of the bridge.

The roadway approaches would be modified for the minor profile adjustments and metal beam railings provided on both sides. The abutments would be protected with riprap and the channel banks stabilized in the vicinity of the new bridge. Relocation of a 12" water main on the south side of the bridge and a buried 6" gas main on the north side of the bridge are anticipated.
